Imagery depicting the view towards the site (Montage pre- and post-mitigation establishment)

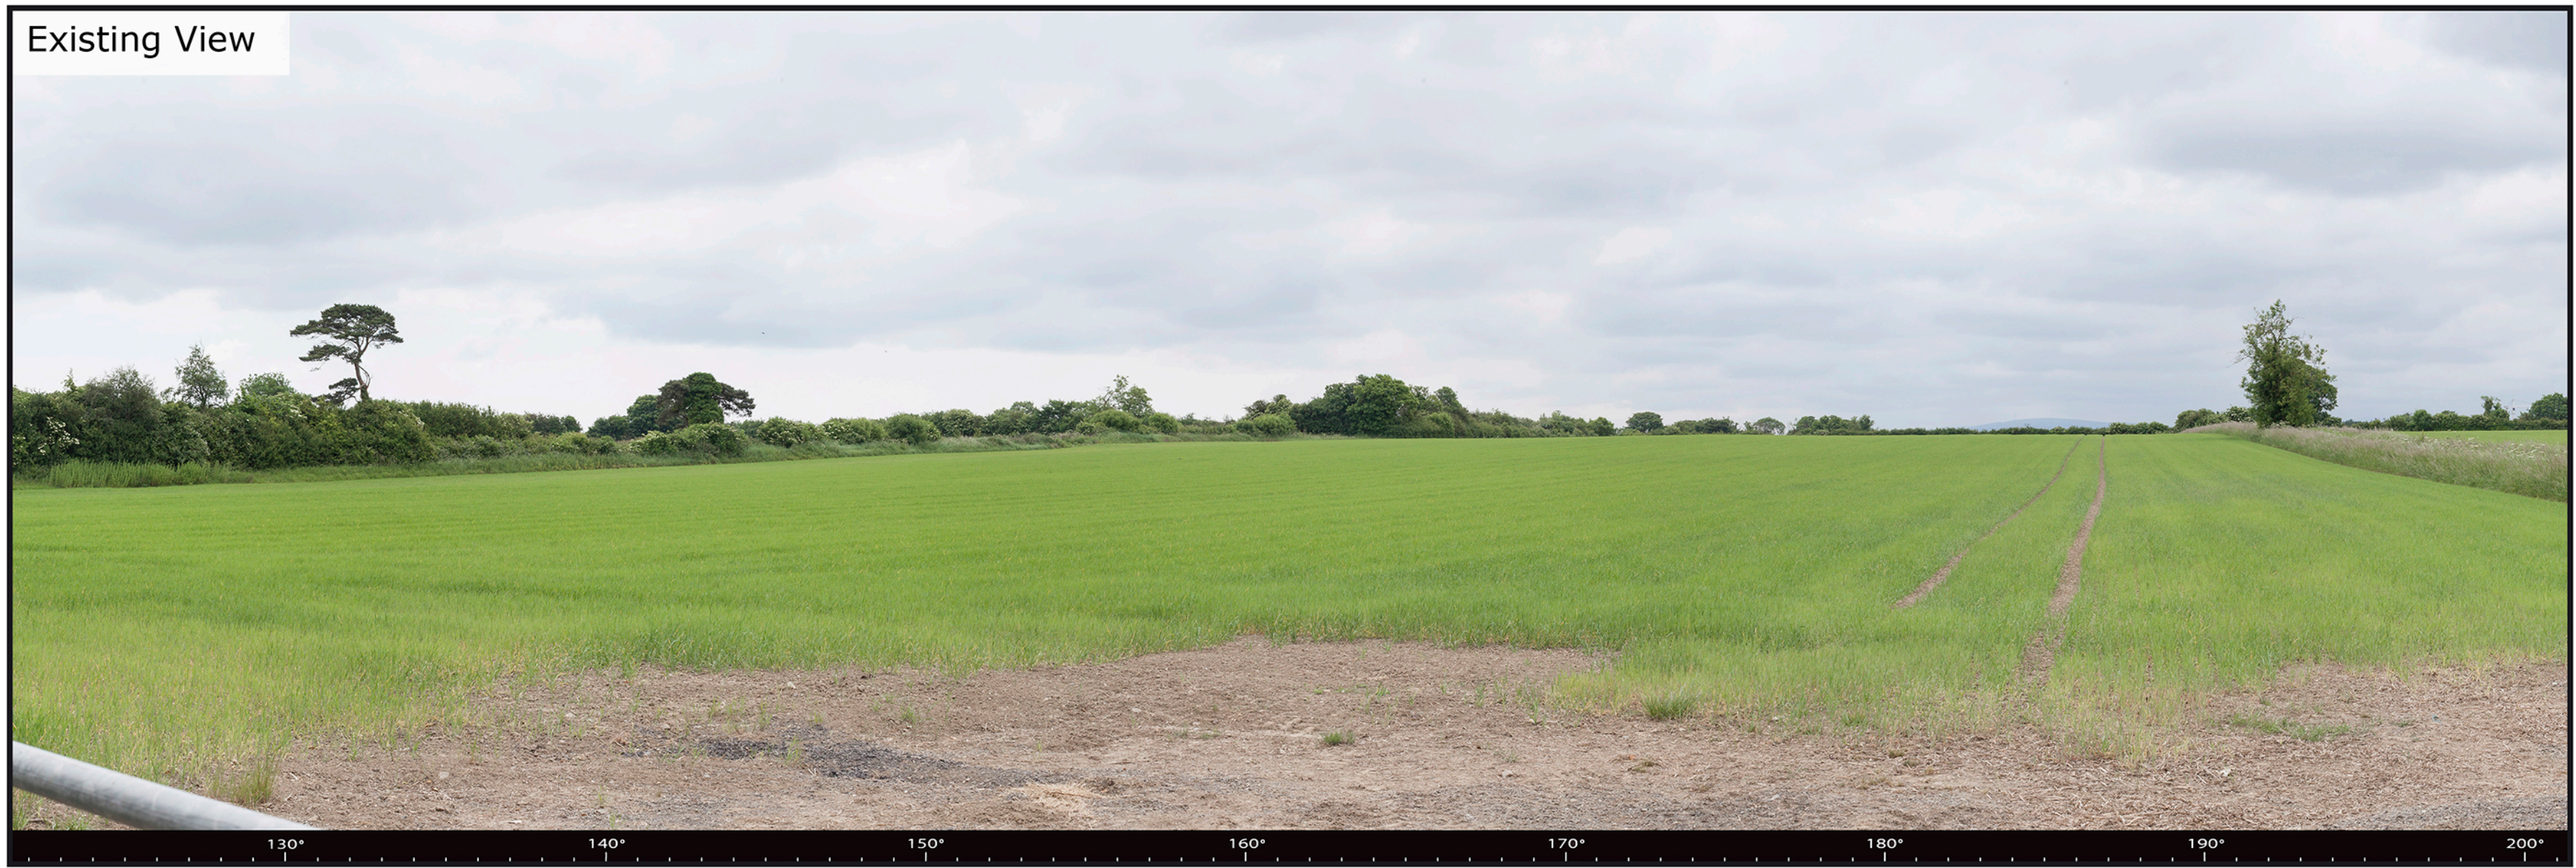
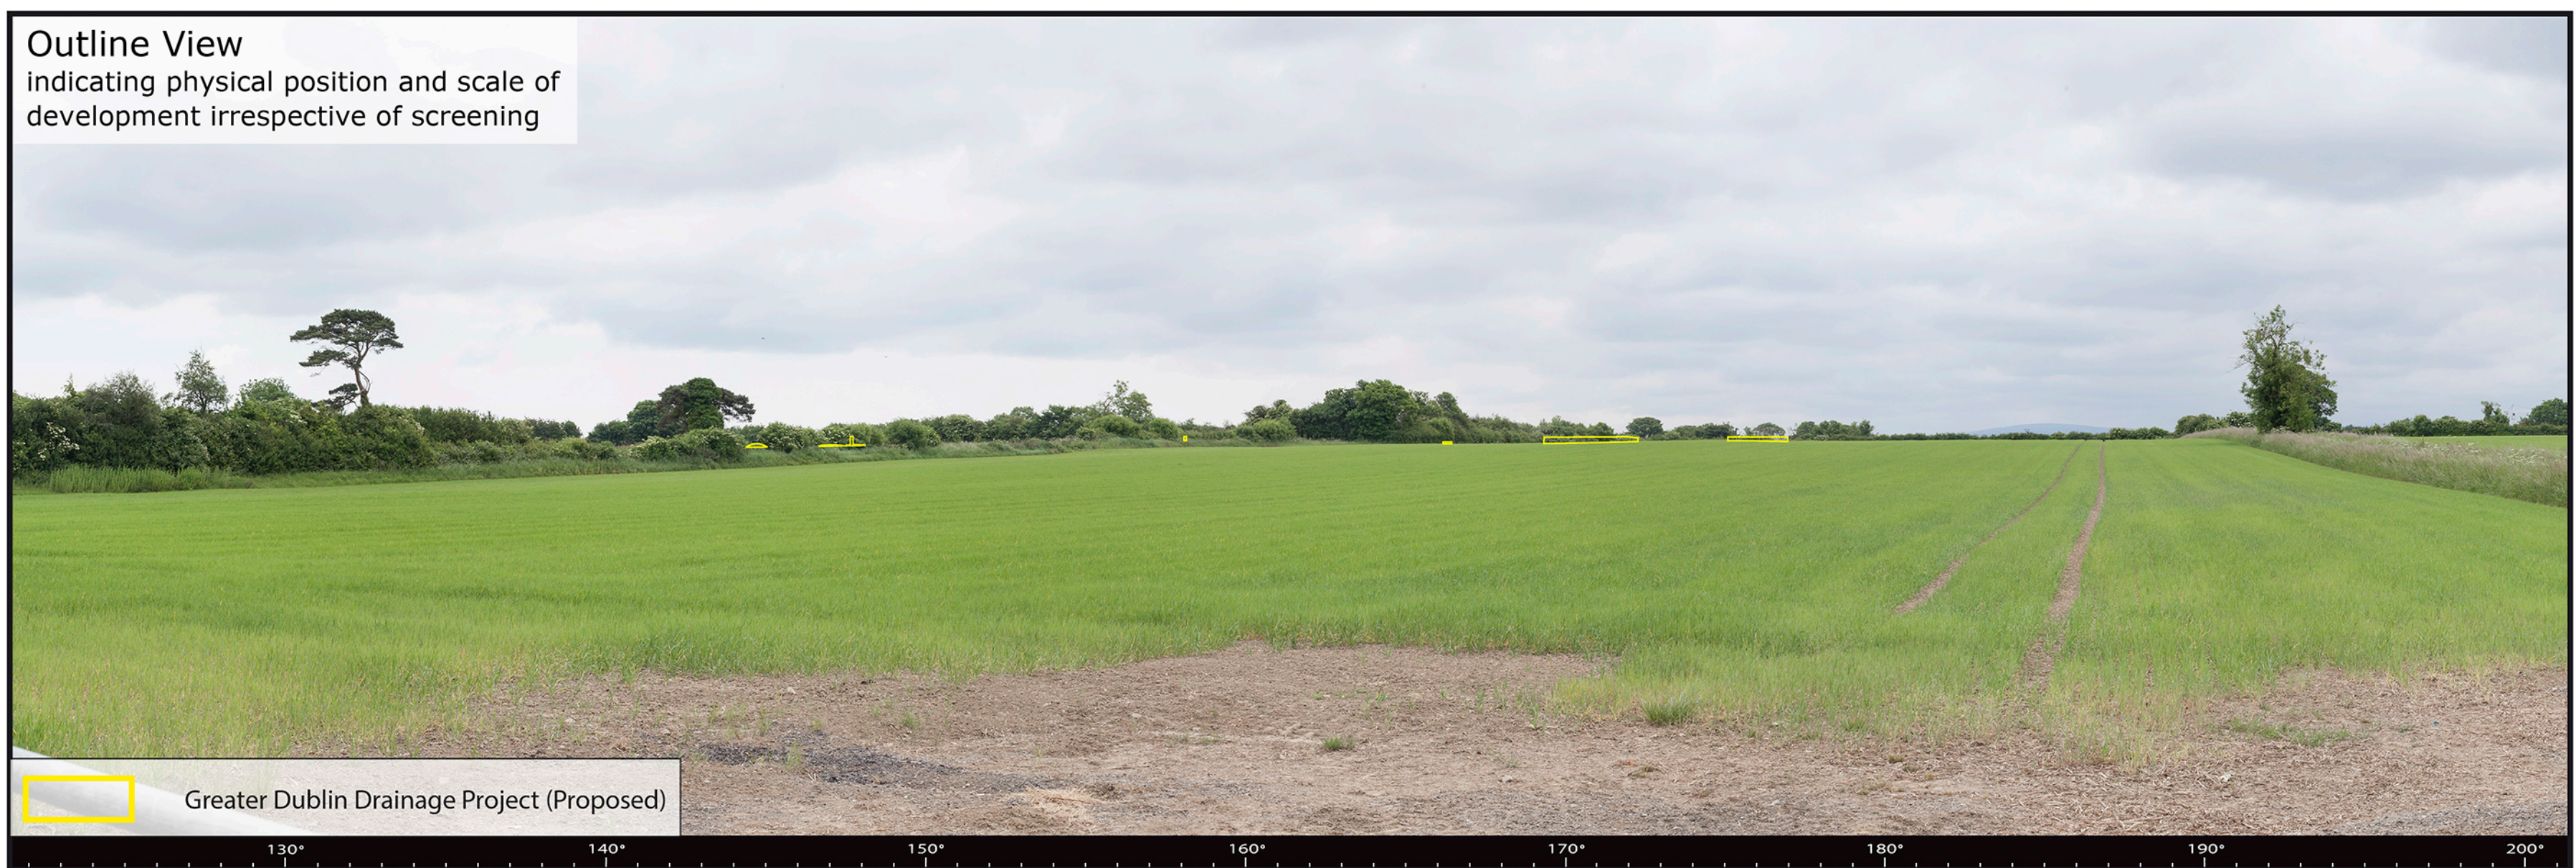
These are 80° panoramic montages captured and presented in accordance with the guidance set by the British Landscape Institute 2011 - Advice Note 01/11.

To view these panoramas on a flat surface one must move from left to right along its length whilst maintaining a perpendicular viewing direction and the specified **correct viewing distance of 30cm**. To see this entire panoramic scene in reality would necessitate turning one's head through 40°.

Easting (ITM):	719037	Lens:	50mm / Full Frame Sensor	Date:	12-Jun-18
Northing (ITM):	743168	Camera:	Canon 1-D Mark II digital SLR	Time:	12:18
Direction of View:	161° E of Grid North	Camera Height:	1.7m Above Ground Level		
Angle of View:	80°

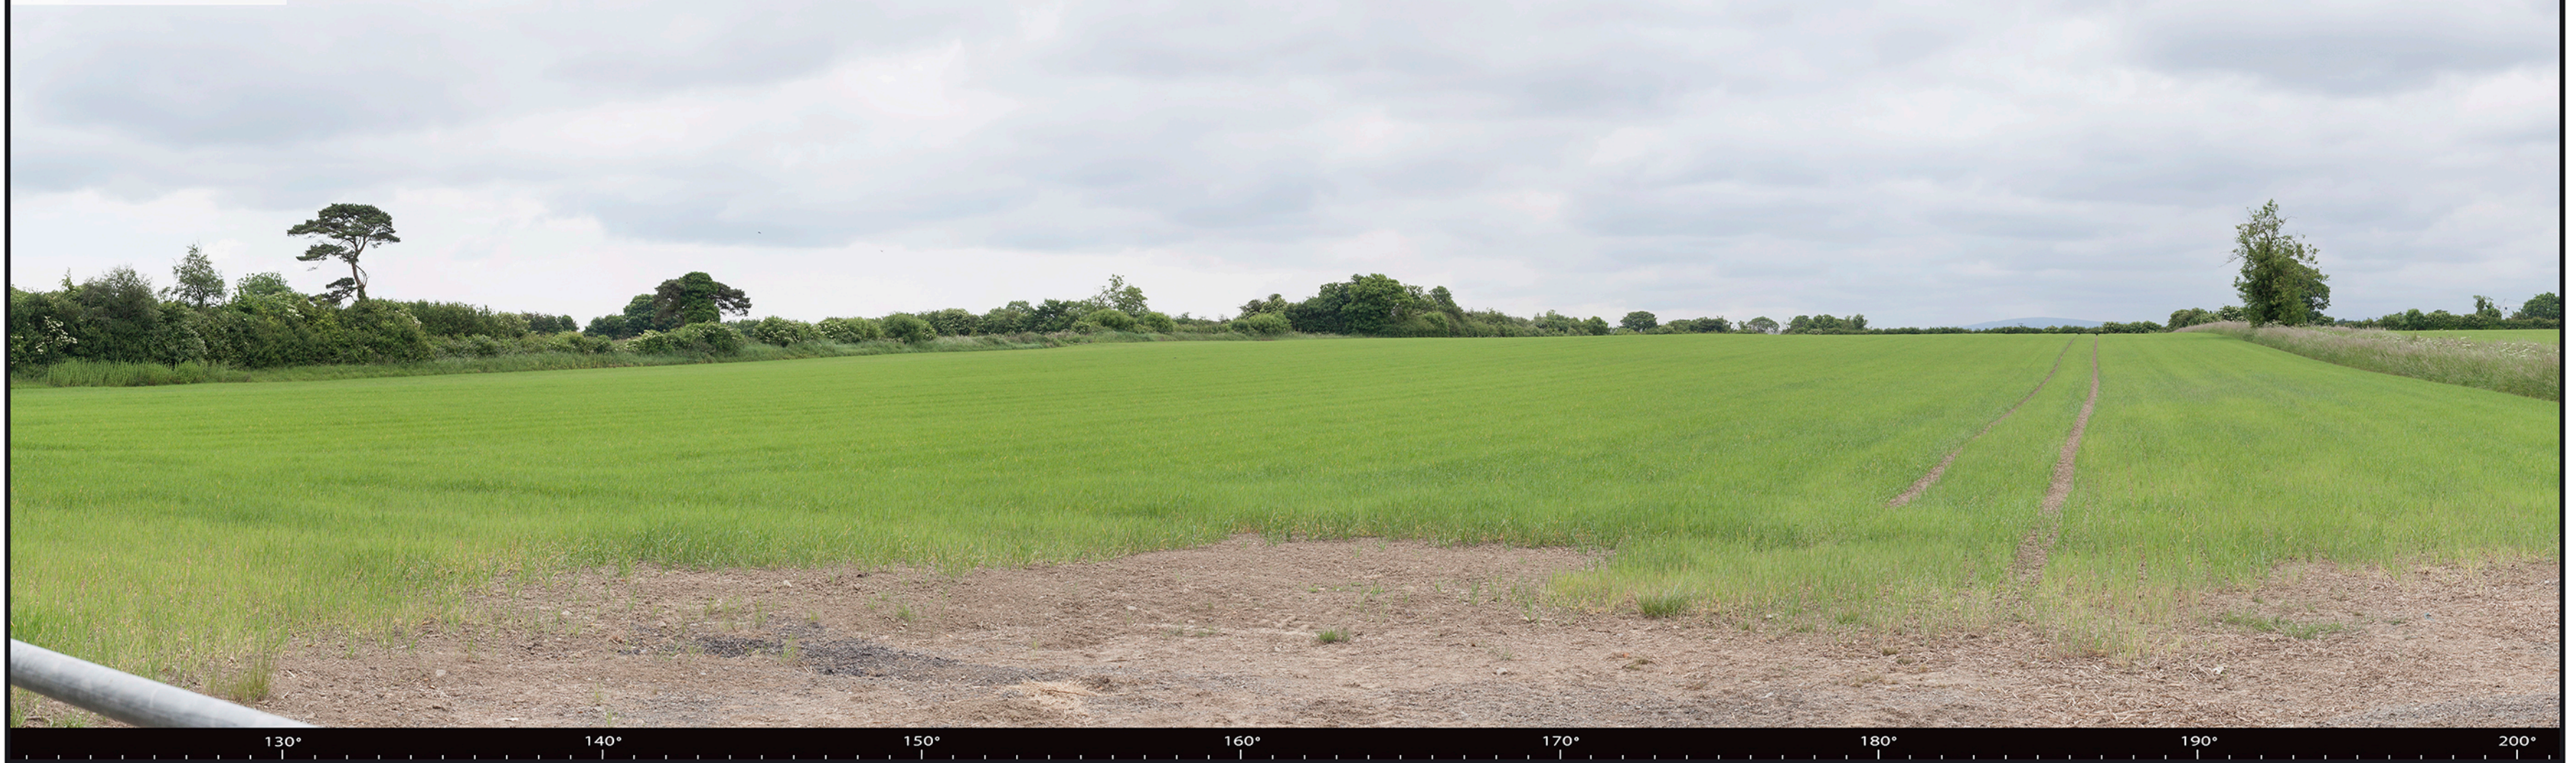
Montage View  
Pre-Mitigation

These are 80° panoramic montages captured and presented in accordance with the guidance set by the British Landscape Institute 2011 - Advice Note 01/11.

To view these panoramas on a flat surface one must move from left to right along its length whilst maintaining a perpendicular viewing direction and the specified **correct viewing distance of 30cm**. To see this entire panoramic scene in reality would necessitate turning one's head through 40°.

Easting (ITM):	719037	Lens:	50mm / Full Frame Sensor	Date:	12-Jun-18
Northing (ITM):	743168	Camera:	Canon 1-D Mark II digital SLR	Time:	12:18
Direction of View	161° E of Grid North	Camera Height:	1.7m Above Ground Level		
Angle of View:	80°
